Castle Rock Fire Straw Monitoring Report

Prepared by John Chatel (Aquatics Program Manager Sawtooth NF)
and Terry Hardy (Sawtooth and Boise NFs Soil Program Manager)
October 26, 2009

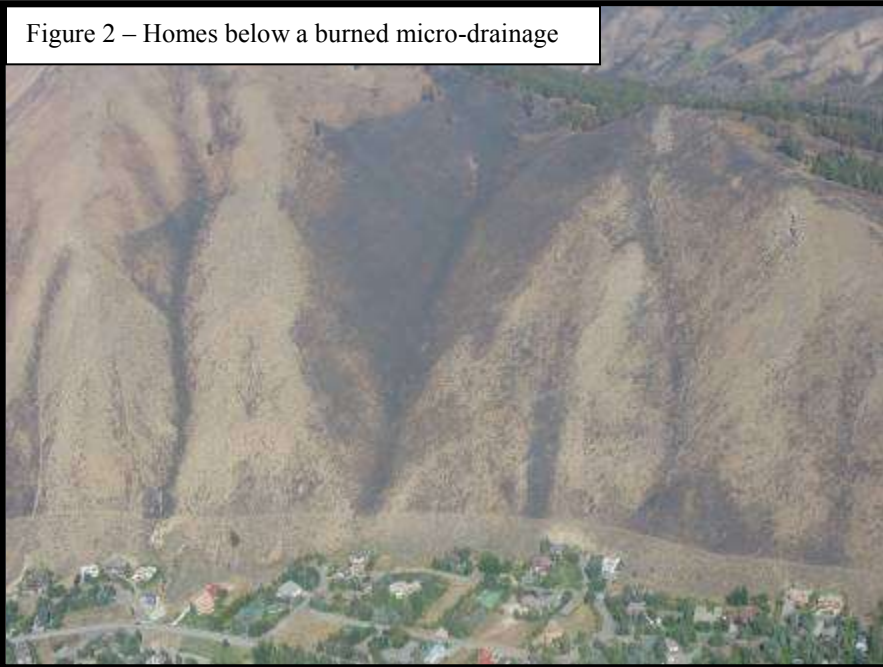
Figure 2 – Homes below a burned micro-drainage

Field reviews after the BAER assessment by John Thornton (hydrologist Boise NF) and Pete Robichaud indicated that wood mulch was the best treatment above homes (Figure 2) because proposed units were prone to wind erosion and had no surface vegetation to breakup wind velocities or capture lighter windblown agricultural mulch. Wood straw was less prone to wind erosion than agricultural straw. In wind tunnel testing, wood strand mulch resisted wind velocities of up to 40 mi h⁻¹ (18 m s⁻¹)

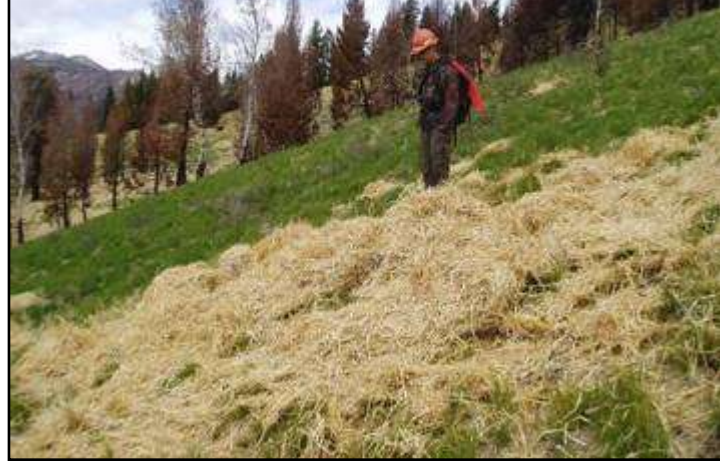
Figure 3 - Heavy Straw in portion of Hot Springs North unit in 2008

Only a few sites in the Hot Springs North unit had excessive clumping that inhibited growth of grasses and forbs (Figure 3). These sites were some of the first areas flown in 2008 and the helicopter pilots were still adjusting their drop heights and airspeeds. So it was not surprising some clumping of agricultural straw occurred. As the helicopter drops progressed through the project the contractor adjusted their straw preparation and application techniques resulting in very little clumping of remaining units. Only minor clumping was found in the wood straw units due in part to excellent preparation (i.e. ramming and dropping wood straw bales with a fork lift) of the wood straw before it was loaded into cargo nets.

Mulch did not reduce vegetative ground cover in any of the treated areas. Grass, forbs, and small woody species were able to easily grow through the wood and agricultural mulch. Only a few sites in the Hot Springs North unit had excessive clumping that inhibited regrowth of grasses and forbs.

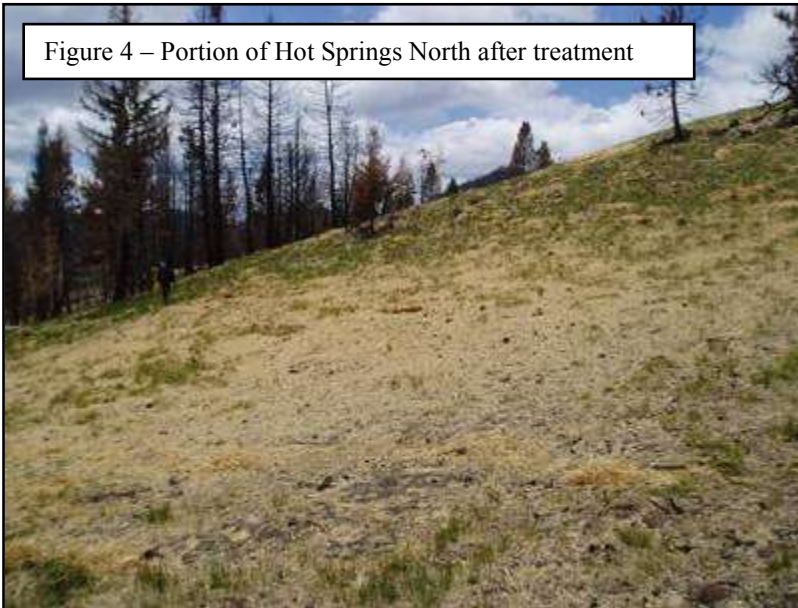
Figure 4 – Portion of Hot Springs North after treatment

Originally there was good coverage of agricultural straw after it was applied. However, very few sites in 2009 still retained this coverage (Figures 4 and 5). Straw that remained mainly occurred in lower or mid slope areas of each unit, or behind large rocks, trees, low lying shrubs or in shallow depressions protected from the wind. It is unknown how long the agricultural straw remained in place. But clearly this material did not provide ground cover for the desired length of time. All of the treated hillslopes were subjected to

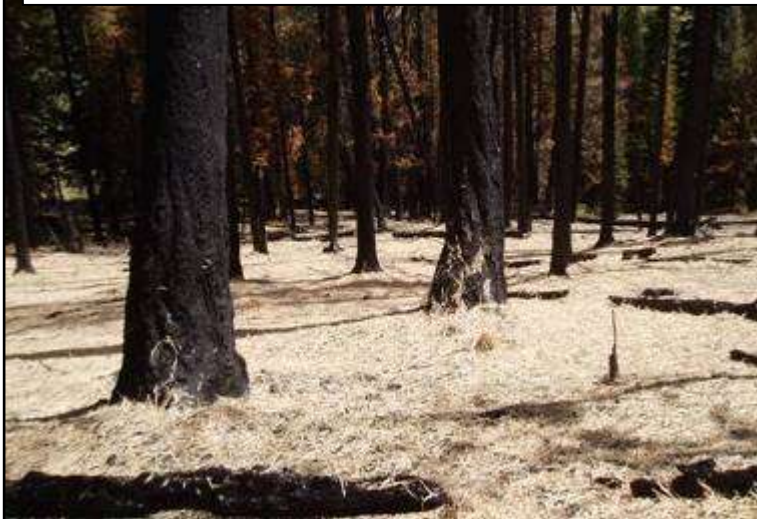
Figure 6 – Wood straw coverage in Board Ranch North in 2008

Eleven of the 12 transects where wood straw was applied had less mulch over the monitored timeframe (Figures 6 and 7). Wood mulch sites averaged a 19.8% (1 to 56% range) decrease in straw than the previous year. All nine transects where agricultural straw was applied also had less mulch. Agricultural mulch sites averaged a 30.7% (5 to 58% range) decrease in straw than what was present after application in 2008. Decreases were due to agricultural and some wood straw being moved by wind especially near ridges, wood or wheat strands settling or decaying to less than the required thickness to be included as ground cover, the original transect line being missed and not resurveyed, and/or observer variability in how ground cover was classified.

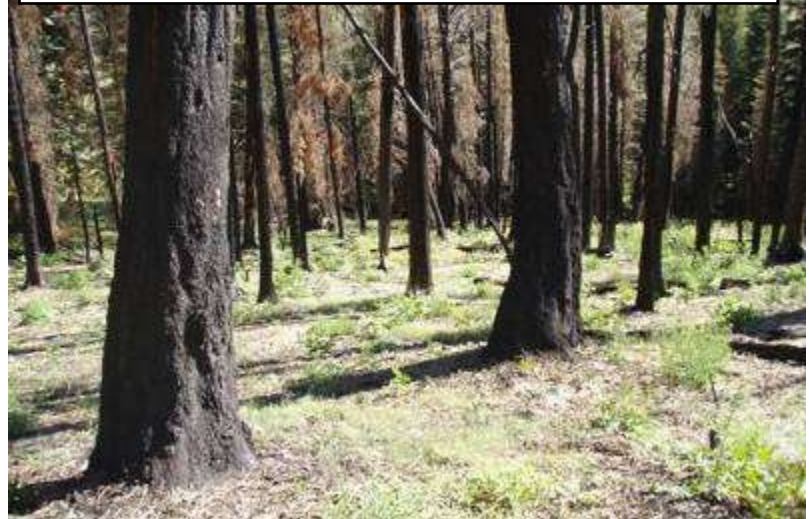
Figure 7 – Wood straw coverage in Board Ranch North in 2009

Although straw coverage decreased at most sites, it is still providing some ground cover and hillslope protection especially at the wood straw sites. Wood mulch ground cover averages 29.3% (0-39% range) and agricultural mulch averages 20.1% (14 to 44% range). Without mulch ground cover would only average 54% over all treated transects.

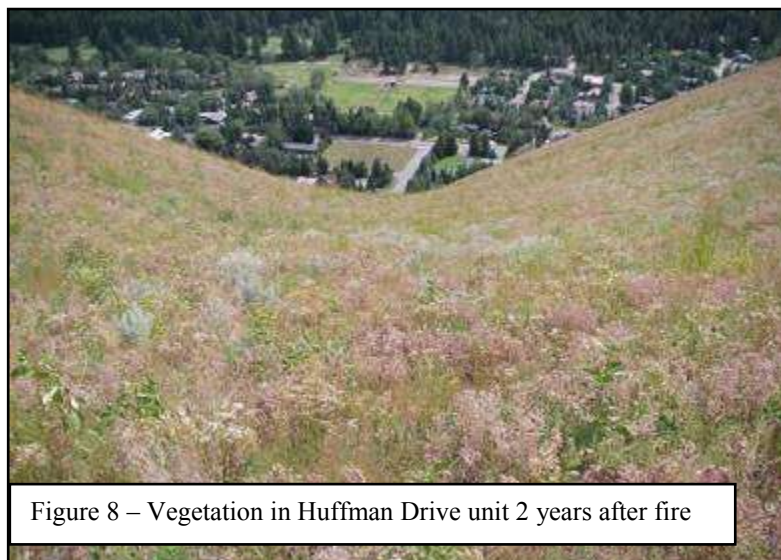
Figure 8 – Vegetation in Huffman Drive unit 2 years after fire

Five of the six treated hillslopes are on south facing aspects that were dominated by sagebrush, grasses, and pockets of conifers near ridges before the fire. Transects completed during the BAER assessments showed that portions of these non-forested slopes burned at high severity due to thick pockets of sagebrush increasing the fire's residence time at the soil's surface. The fire also removed all

vegetative ground cover leaving only coarse gravel-sized rock fragments in volcanic derived soils and coarse sand/small rock in Batholith derived soils.

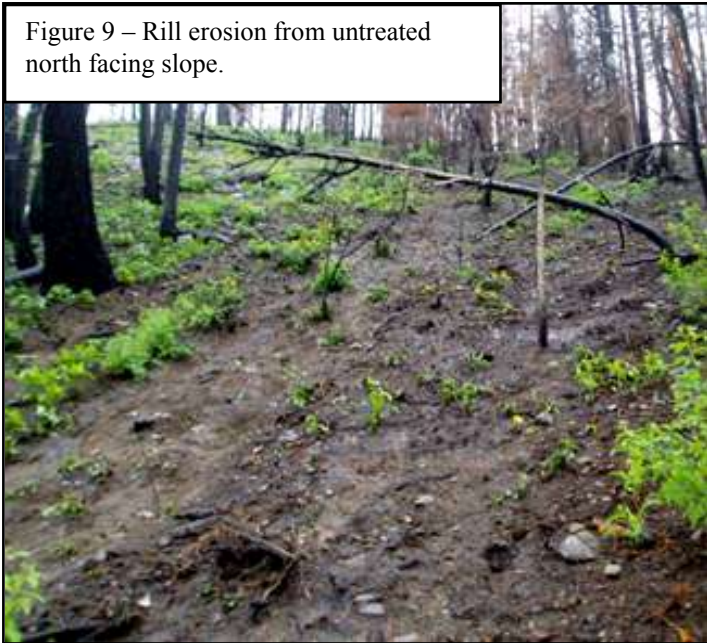
Figure 9 – Rill erosion from untreated north facing slope.

Rill erosion was only found within a few conifer stands on south facing slopes and more so on untreated north facing slopes that burned at a higher intensity and severity. These areas are characterized by high water repellency, limited ground cover, loss of litter/duff layer, and sparse overstory (Figure 9). Overland flow on north facing slopes from intense rainfalls of 2009 caused rill erosion that collected into smaller and larger channels. Since the terrain is very steep, debris torrents quickly gained momentum continuously scouring channels over several miles until they reached the valley floor creating multiple alluvial fans (Figure 10).
